NASA Technical Memorandum 85831

**FIELD REPAIR OF AH-1G HELICOPTER
WINDOW CUTTING ASSEMBLIES**

Laurence J. Bement

May 1984

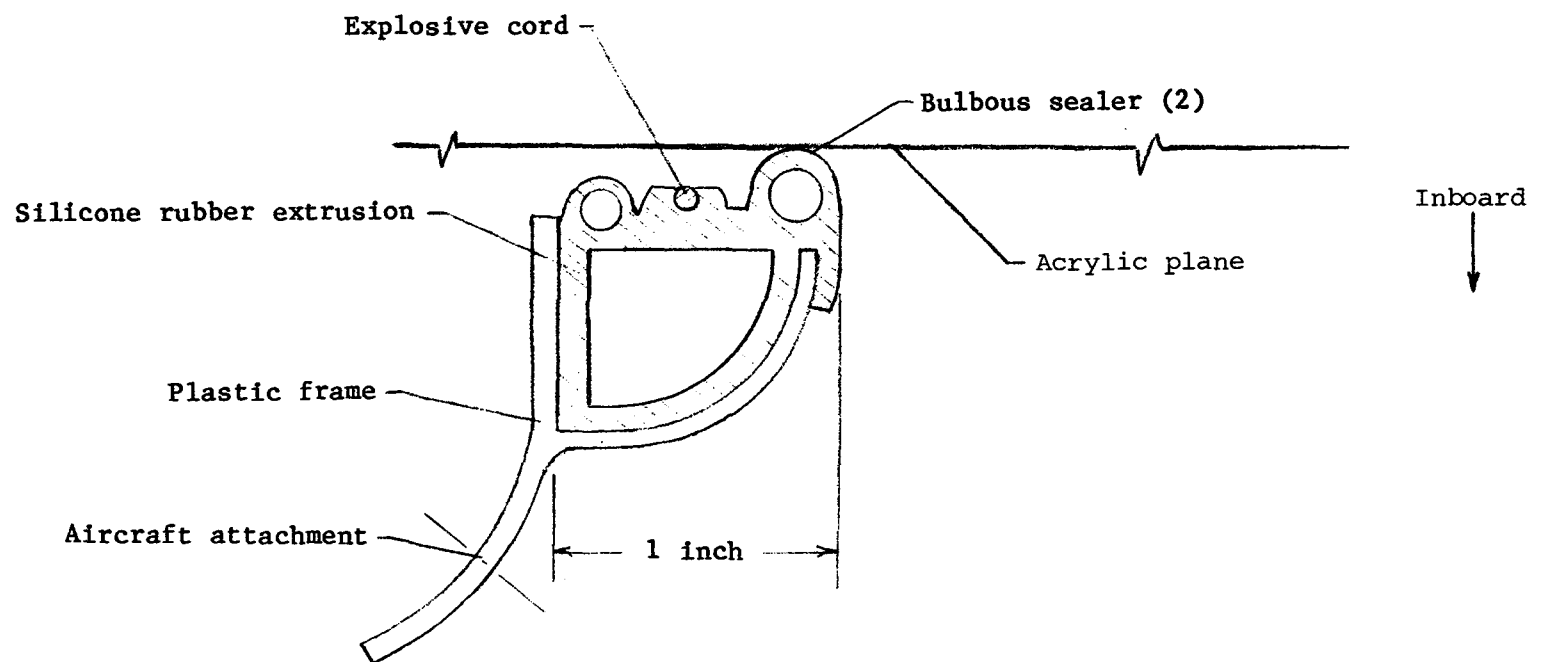
The explosive cords are mounted in flexible, black, silicone-rubber extrusions (see fig. 1), which in turn are housed by plastic frames, mounted to either the air-frame on the two windows or to the two door frames. The explosive cords are silver or lead-sheathed and contain 2.5 grains/foot hexanitrostilbene-II. The silicone rubber was extruded into an approximately 1-inch wide triangular cross section, which contains a large air cavity to dissipate the explosive pressures propagating inboard into the aircraft. The extrusion also contains bulbous areas on either side of the explosive cord to prevent contamination of the explosive cord-to-acrylic interface after the assembly has been mounted against the acrylic. The plastic frames are General Electric materials, EKE-450 or Lexan polycarbonates.

Figure 1.- Cross section of window cutting assembly, showing the explosive cord, silicone extrusion and plastic frame.
